IISEE Newsletter No.80

Quick Report on Damage to Buildings by the Tornado on May 6, 2012 in Tsukuba City, Ibaraki Prefecture, JAPAN

National Institute for Land and Infrastructure Management (NILIM),
Ministry of Land, Infrastructure, Transport and Tourism (MLIT)
(Incorporated Administrative Agency) Building Research Institute (BRI)

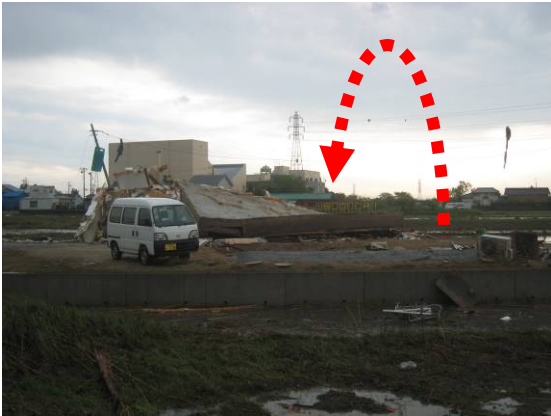
A wooden structure A (Photos 1, 2) completely turned over with detached flat basement from ground.

Photo 1 Wooden Building A

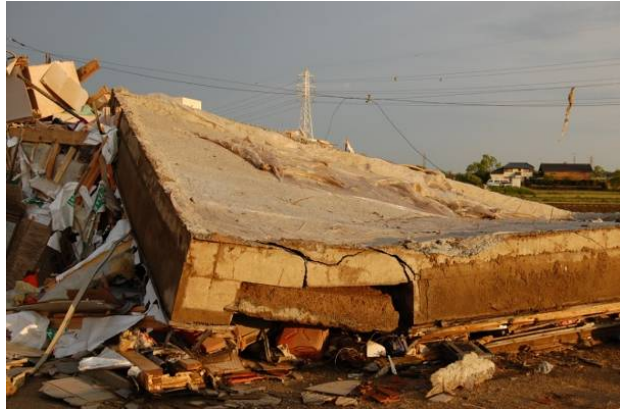
Photo 2 Turned flat basement of Wooden Building A

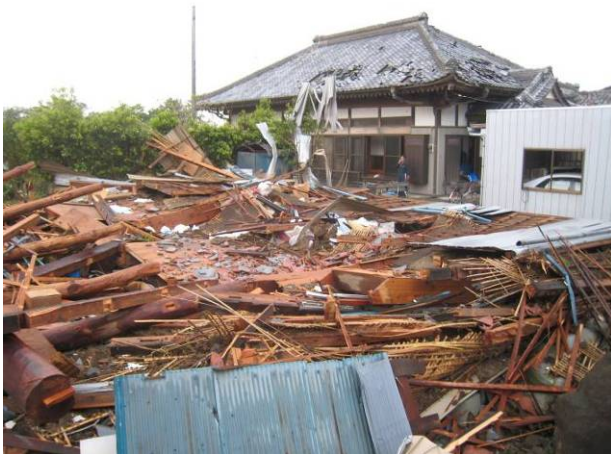
Though the details of the collapsed structure cannot be grasped, wooden structure B (this side, Photo 3) and C (Photo 4) totally collapsed because tornado-induced wind load was estimated to surpass load-carrying capacity of these structures.

Photo 3 Wooden building B (this side, collapsed one)

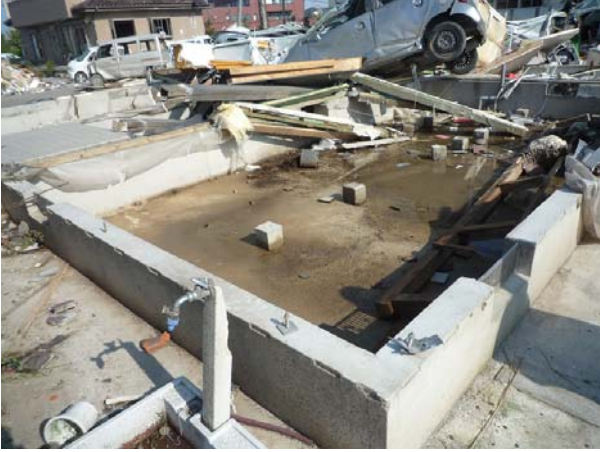
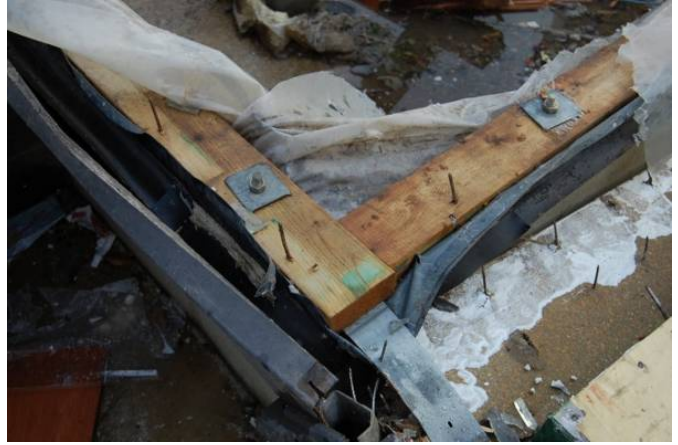
Whole upper structures (of wooden buildings D and E) were scattered. In the case of wooden building D (Photo 5), a part of the foundation beam remained (Photo 6) but most of upper structures were scattered. And in the case of wooden building E (Photo 7) upper parts of floor board were scattered.

Photo 5 Wooden Building D Photo 6 Remaining foundation beam of Wooden Building D

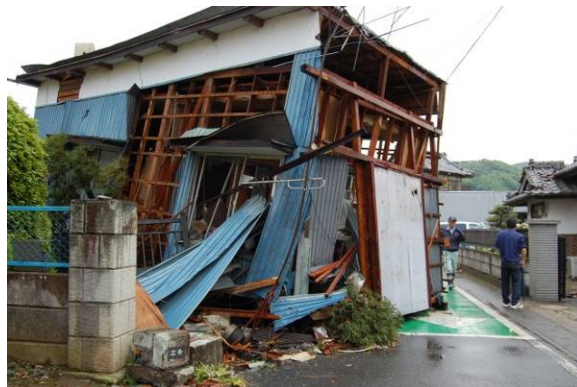
Photo 8 Wooden Building F

A case of horizontal movement of upper structure to the road was observed (Wooden Building F, Photo 8). Anchor bolts or connection of columns and foundation beam were collapsed by stronger horizontal force of tornado.

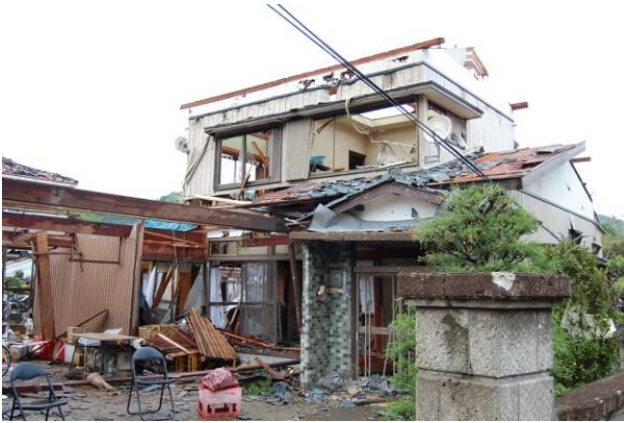
Photo 9 Wooden Building G

Many cases of damage to roof truss's were observed. The damage cases are shown in Photo 9 of a gable roof (comparatively old house), Photo 10 of a gable roof (comparatively new house), Photo 11 of a hipped roof and Photo 12 of a pent roof, respectively.

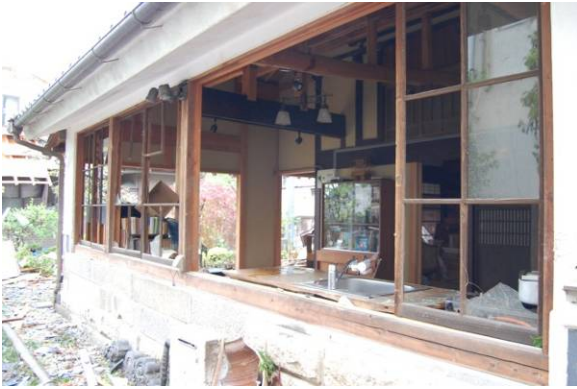
Photo 13 Wooden Building K

Openings are considered to have been broken due to out-of-plane wind pressure or collision of flying debris induced by the tornado.

The damage from out-of-plane wind pressure (Photos 13 and 14) caused breakage of whole openings of affected exterior walls in many cases, while partial damage of openings was seen in the case of collision of flying debris.

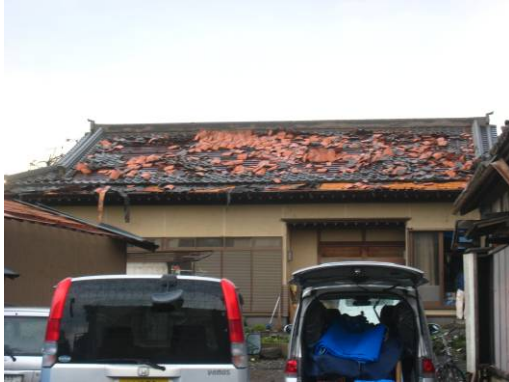
Photo 15 Wooden Building M

Substantial damage to roofing materials was observed (Photo 15). In addition, metal roofing materials were confirmed to have been scattered to considerable distances.

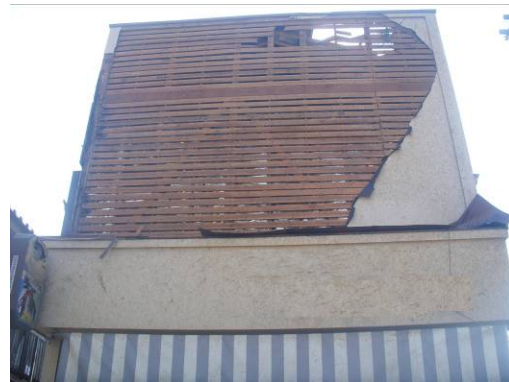
Photo 16 Wooden Building N

On the other hand, dislodging of exterior materials was observed in exterior walls with mortar. In some cases the groundwork materials were confirmed rotten. It is claimed that the mortared exterior walls will not collapse except the cases of additional deformation of other structural components or from additional lateral forces, this cited failure is not determined to occur because of the latter reason of the two.

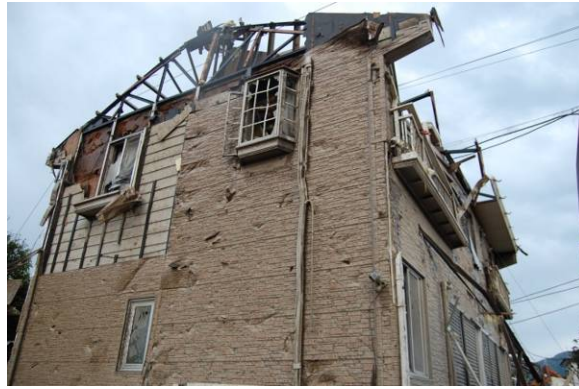
Photo17 Steel Framed Building A

The collapse and scattering of roof trusses with damage of exterior materials and windows were observed in a light-gauge steel framed house.

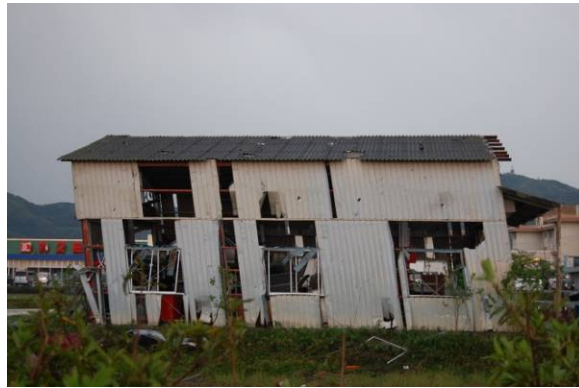
Photo 18 Steel Framed Building B

Residual deformation of structural frame was observed in a warehouse building.

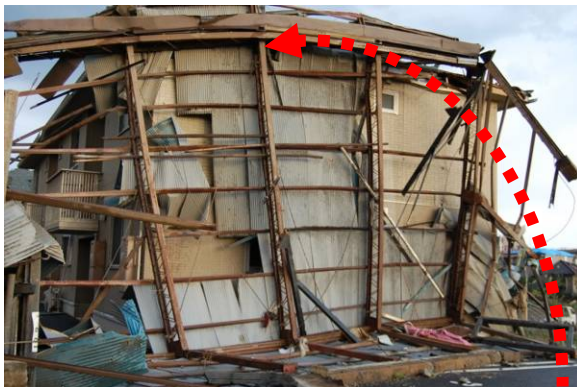
Photo 19 Steel Framed Building C

A steel framed building used as a garage fell down and turned sideways.

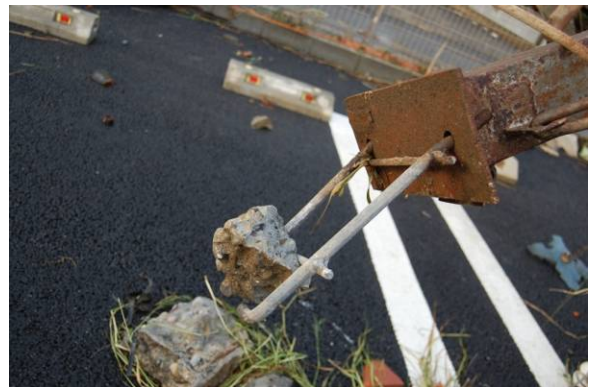
Photo 20 Pull out of column base shown in Photo 19

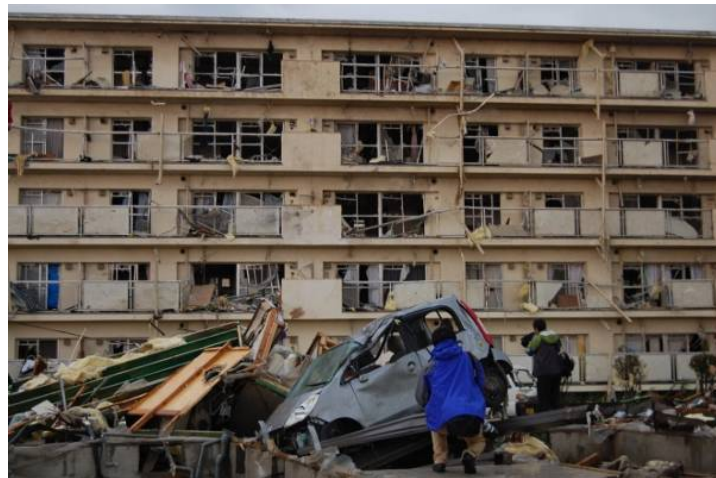
Window glass, frames, handrails of verandah etc. of a five-story multifamily housing were

significantly damaged on the south side. Similar damage was observed on the north side although the openings were small.

Photo 21 South side of a public multifamily housing

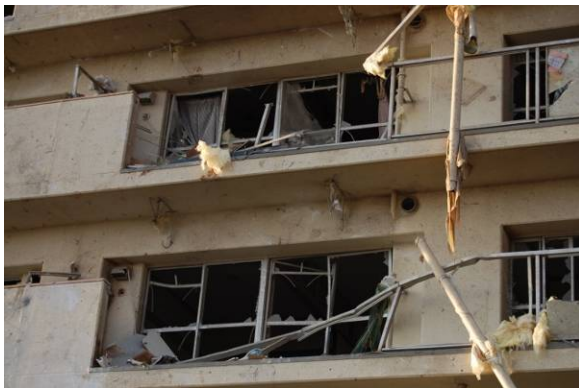
Photo 22 Windows and handrails 1

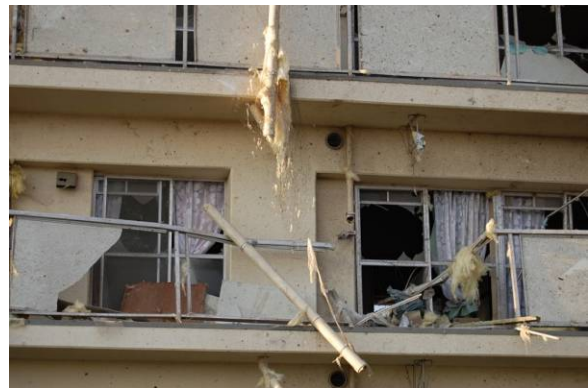
Photo 23 Windows and handrails 2

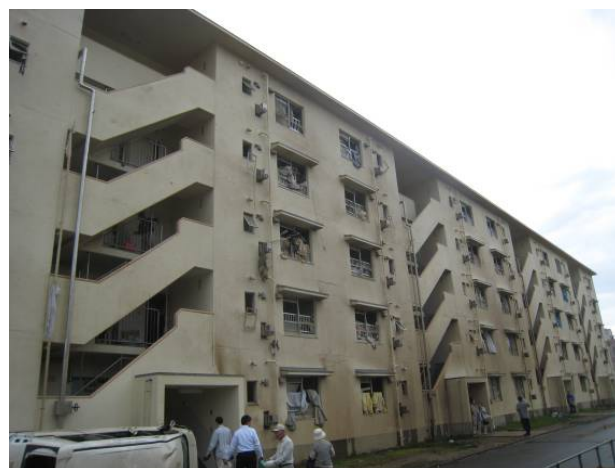
Photo 24 North side of a public multifamily housing

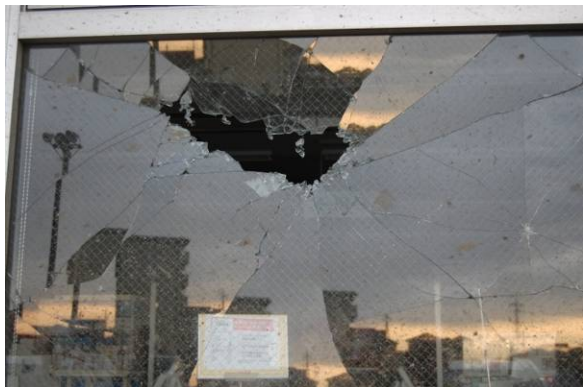
Photos 25 and 26 show traces of collision at an entrance of a shopping center, Photos 27 and 28 show the collision of flying roof/roofing materials and Photo 29 shows a flying roofing material hung at electric cables.

Photo 25 Evidence of collision to window

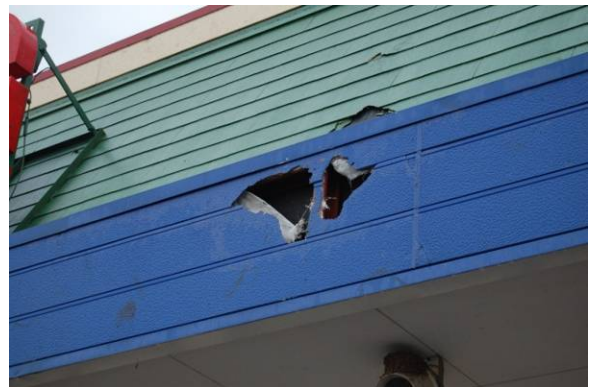
Photo 26 Evidence of collision to exterior material

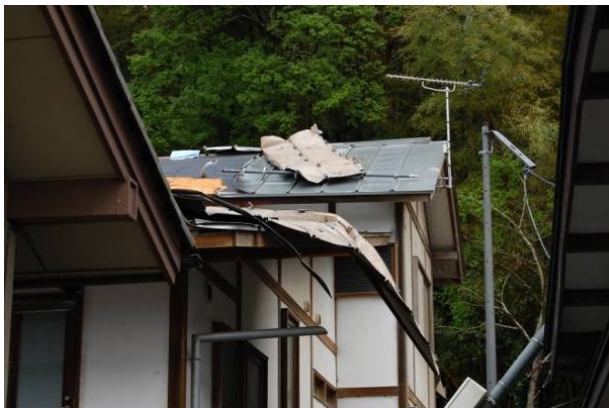
Photo 27 Scattered long steel roofing materials

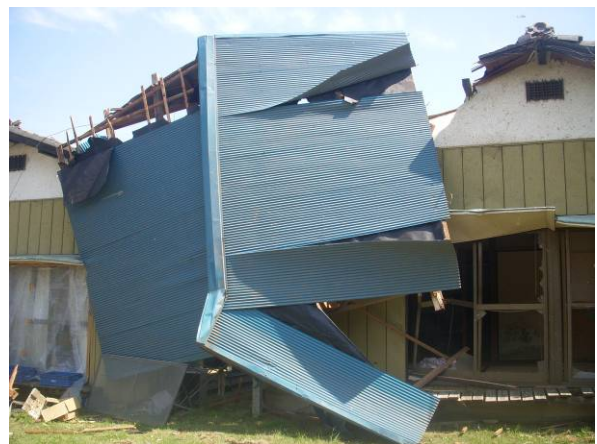
Photo 28 Collision of flying roof frame

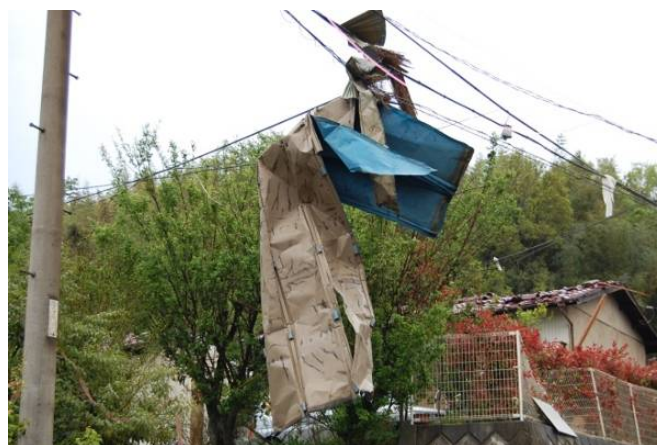
Photo 29 Roofing materials hung at electric cables

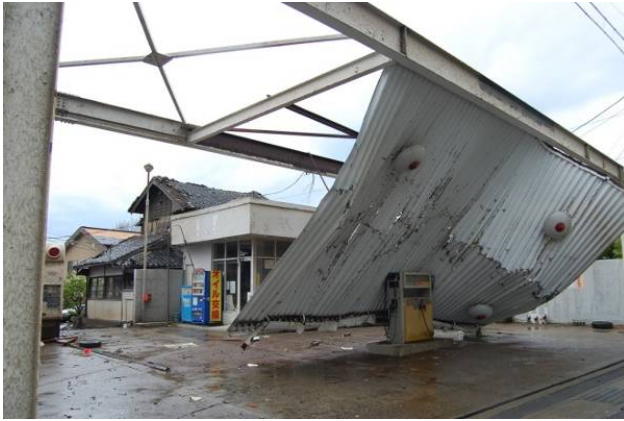
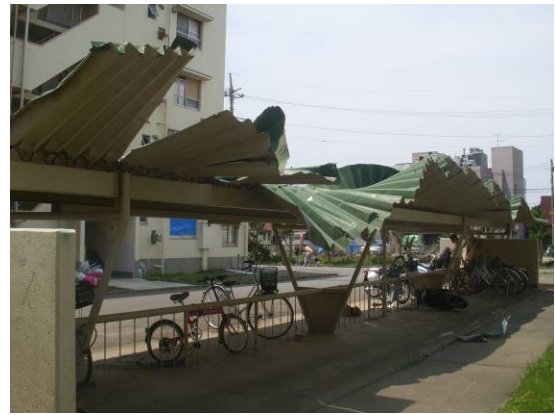
The followings are of additional cases to the previously introduced ones within sections 4.4. Photos 30 and 31 show collapse of a roof at gas station and heavy deformation of roofing materials at a bicycle station, Photo 32 shows collapsed stone fence, Photos 33 and 34 show broken electricity poles, Photo 35 indicates broken trees and Photos 36 and 37 indicate rolling cars etc. Photo 33 shows continuous broken electricity poles or inclined ones while Photo 34 shows the situation of broken electricity pole affecting a neighboring house. Turnover of not only light vehicles but also heavier vehicles and a truck was observed. (Photo 37)

Photo 30 Collapse of a gas station roof Photo 31 Heavy deformation of roof of a bicycle park

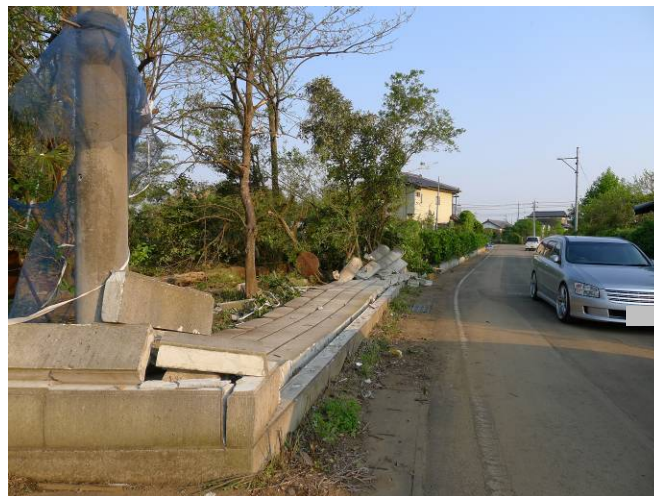
Photo 32 Collapse of stone fence

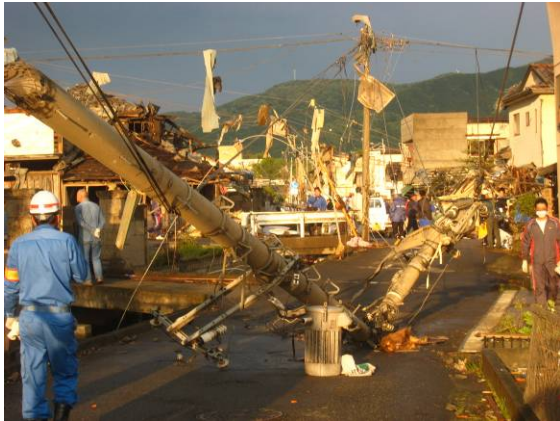
Photo 33 Broken / inclined electricity poles 1

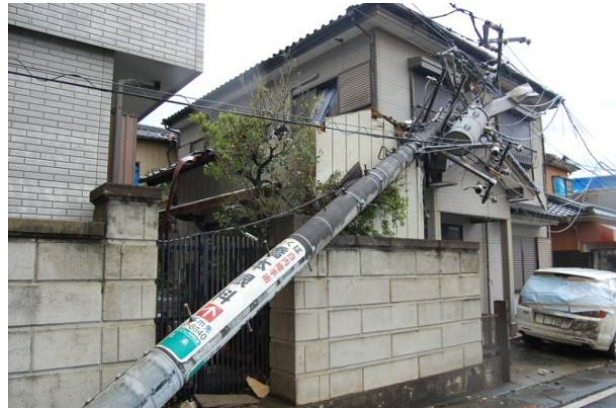
Photo 34 Broken / inclined electricity poles 2

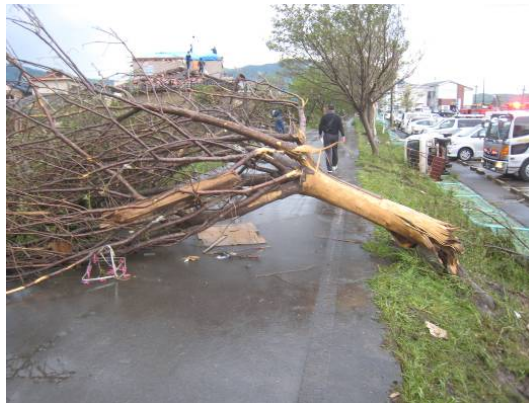
Photo 35 Broken tree

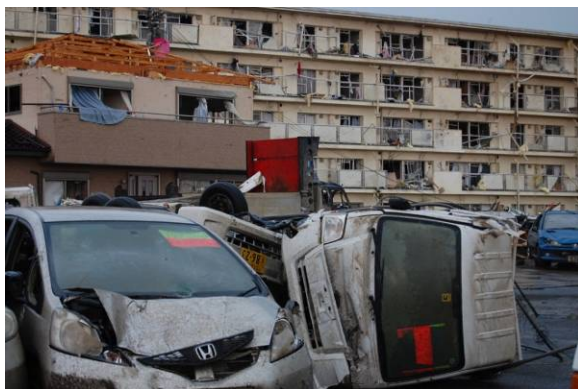
Photo 36 Overturned cars

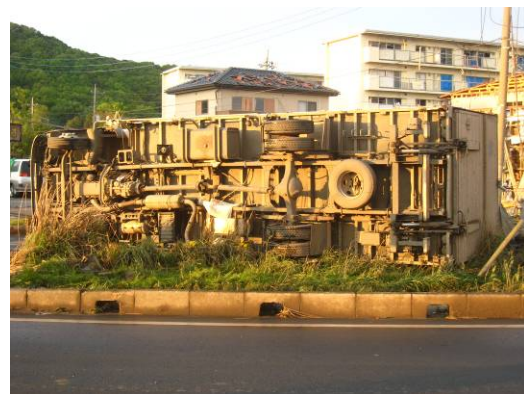
Photo 37 Rolling truck

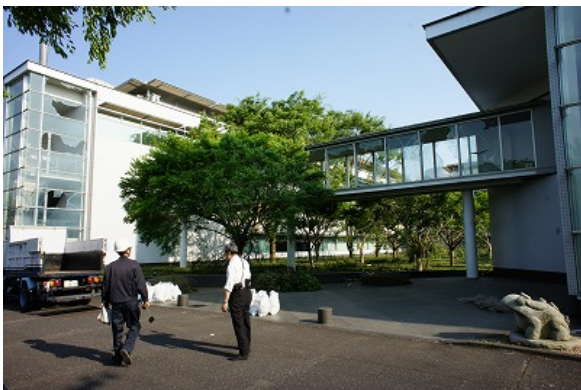
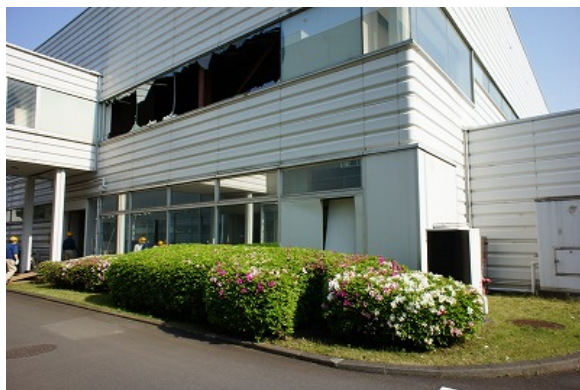
Window breakages were observed at exteriors and within roofed passages of reinforced concrete or

steel framed buildings.

Photo 38 Broken window of a roofed passage Photo 39 Broken window of exterior wall

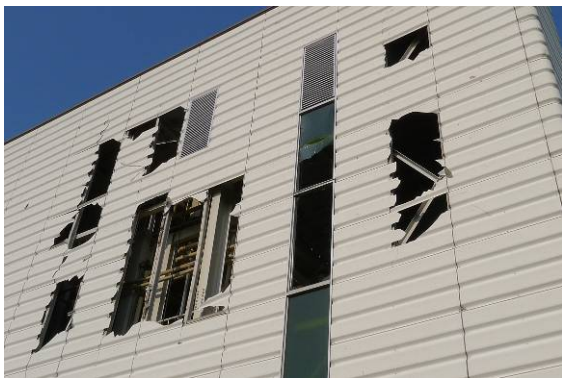
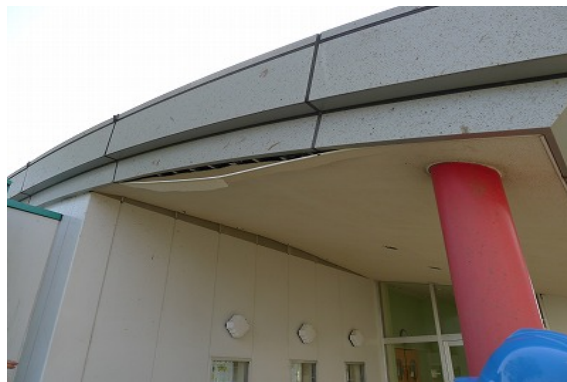
Damage to exterior materials and eave soffits was confirmed in steel framed buildings.

Photo 40 Breakage of exterior and windows Photo 41 Breakage of eave soffits

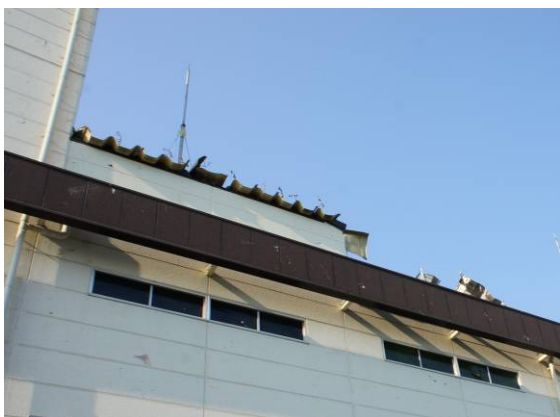
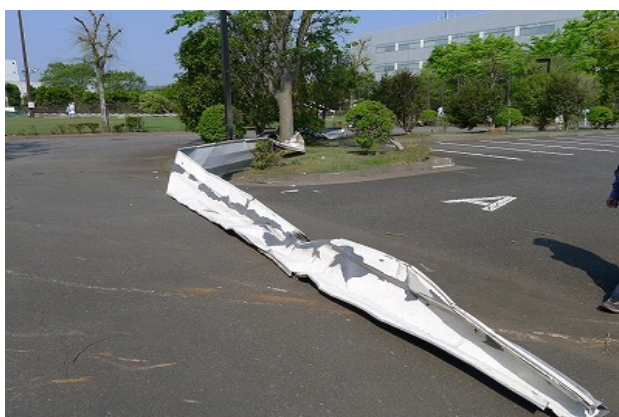
Damage to roofing materials of steel framed buildings was confirmed. Some roofing materials were scattered far to the next factory on the other side of the street more than several dozen meters.

Photo 42 Damage of roofing materials Photo 43 Scattered roofing materials

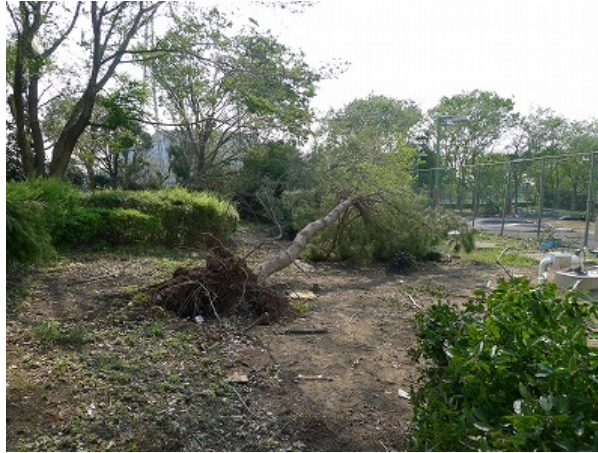
Some cases of broken trees and fallen trees pulled up by the roots were confirmed.

Photo 44 Fallen tree that was pulled up by the root
